March 8, 2006

## HOME INSPECTION REPORT

## Cummings Circle

West Orange, NJ

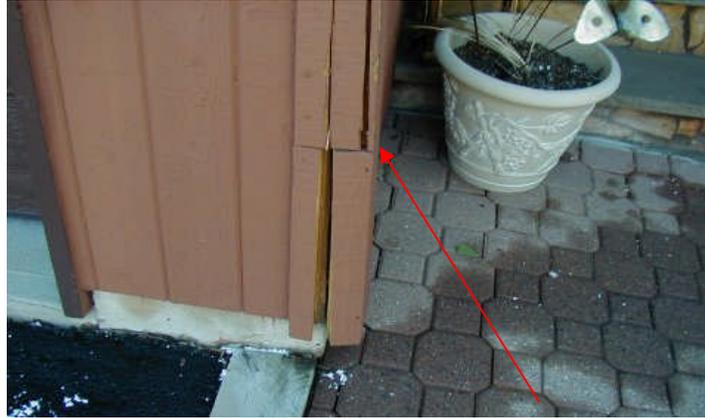
**Wood trim at a corner on the front of the building is loose, possibly from vehicle impact. Roof edge trim boards are warped and weathered in several sections on the front and right side of the upper section of the roof.**

Damaged wood trim

- Advise the condominium association to have the warped/weathered roof edge trim board repaired or replaced as necessary.
- Advise the condominium association to determine responsibility for the damaged corner wood trim in the front, and have damaged wood repaired or replaced.

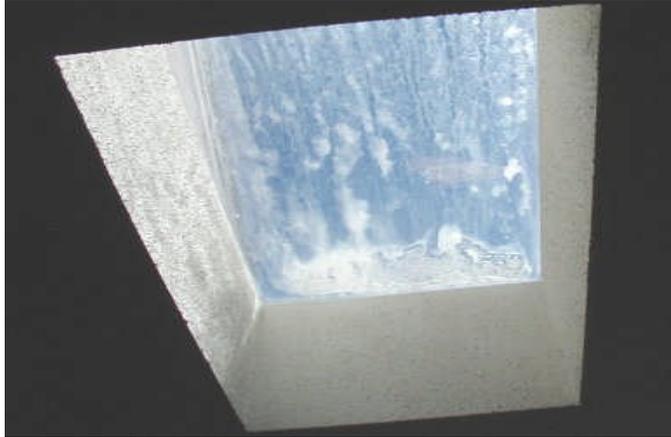
**Skylights on the lower level over the living room have significant staining and/or fogging. This may be caused by a combination of internal fogging between the skylight window panes, exterior staining from weathering, and internal staining.**

**Although no signs of leakage around the skylight into the living space were found on the date of inspection, some leakage into the skylight glass itself may be occurring. In addition, it may not be possible to completely remove any exterior staining and/or internal fogging of these skylights.**

Badly stained skylight

- **Consider having window guards installed on all windows above the first floor level to guard against falling hazards.**
- **Have loose crank knobs tightened, have any windows with peeling interior paint re-painted, and have the loose trim strip repaired.**
- **Have the stained lower level skylights cleaned to the extent possible on both the exterior and interior. If cleaning does not result in a satisfactory appearance, skylight replacement may be necessary to achieve acceptably clear skylights.**

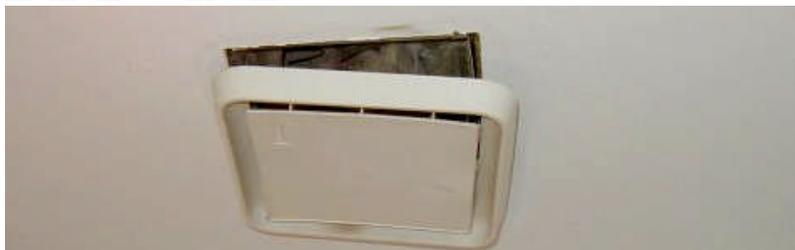
**The exhaust fan in the main bathroom is loose on its mountings, and does not appear to be functional. There is no exhaust fan in the master bathroom. Although a window is present in the master bathroom, the lack of a fan may be contributing to flaking paint in this bathroom.**

**Loose, non-functional exhaust fan in main bathroom**

- **Have a plumber repair the loose sink faucet knobs in the master bathroom.**
- **Have the exhaust fan in the main bathroom on the second floor repaired or replaced.**
- **Consider installation of an exhaust fan in the master bathroom.**
